CALIFORNIA DIVISION OF MINES AND GEOLOGY
FAULT EVALUATION REPORT FER-242
*** SUPPLEMENT No.1 ***

FLEXURAL SLIP FAULTING NEAR PICO CANYON
Los Angeles County, California

by
Jerome A. Treiman

May 17, 1995

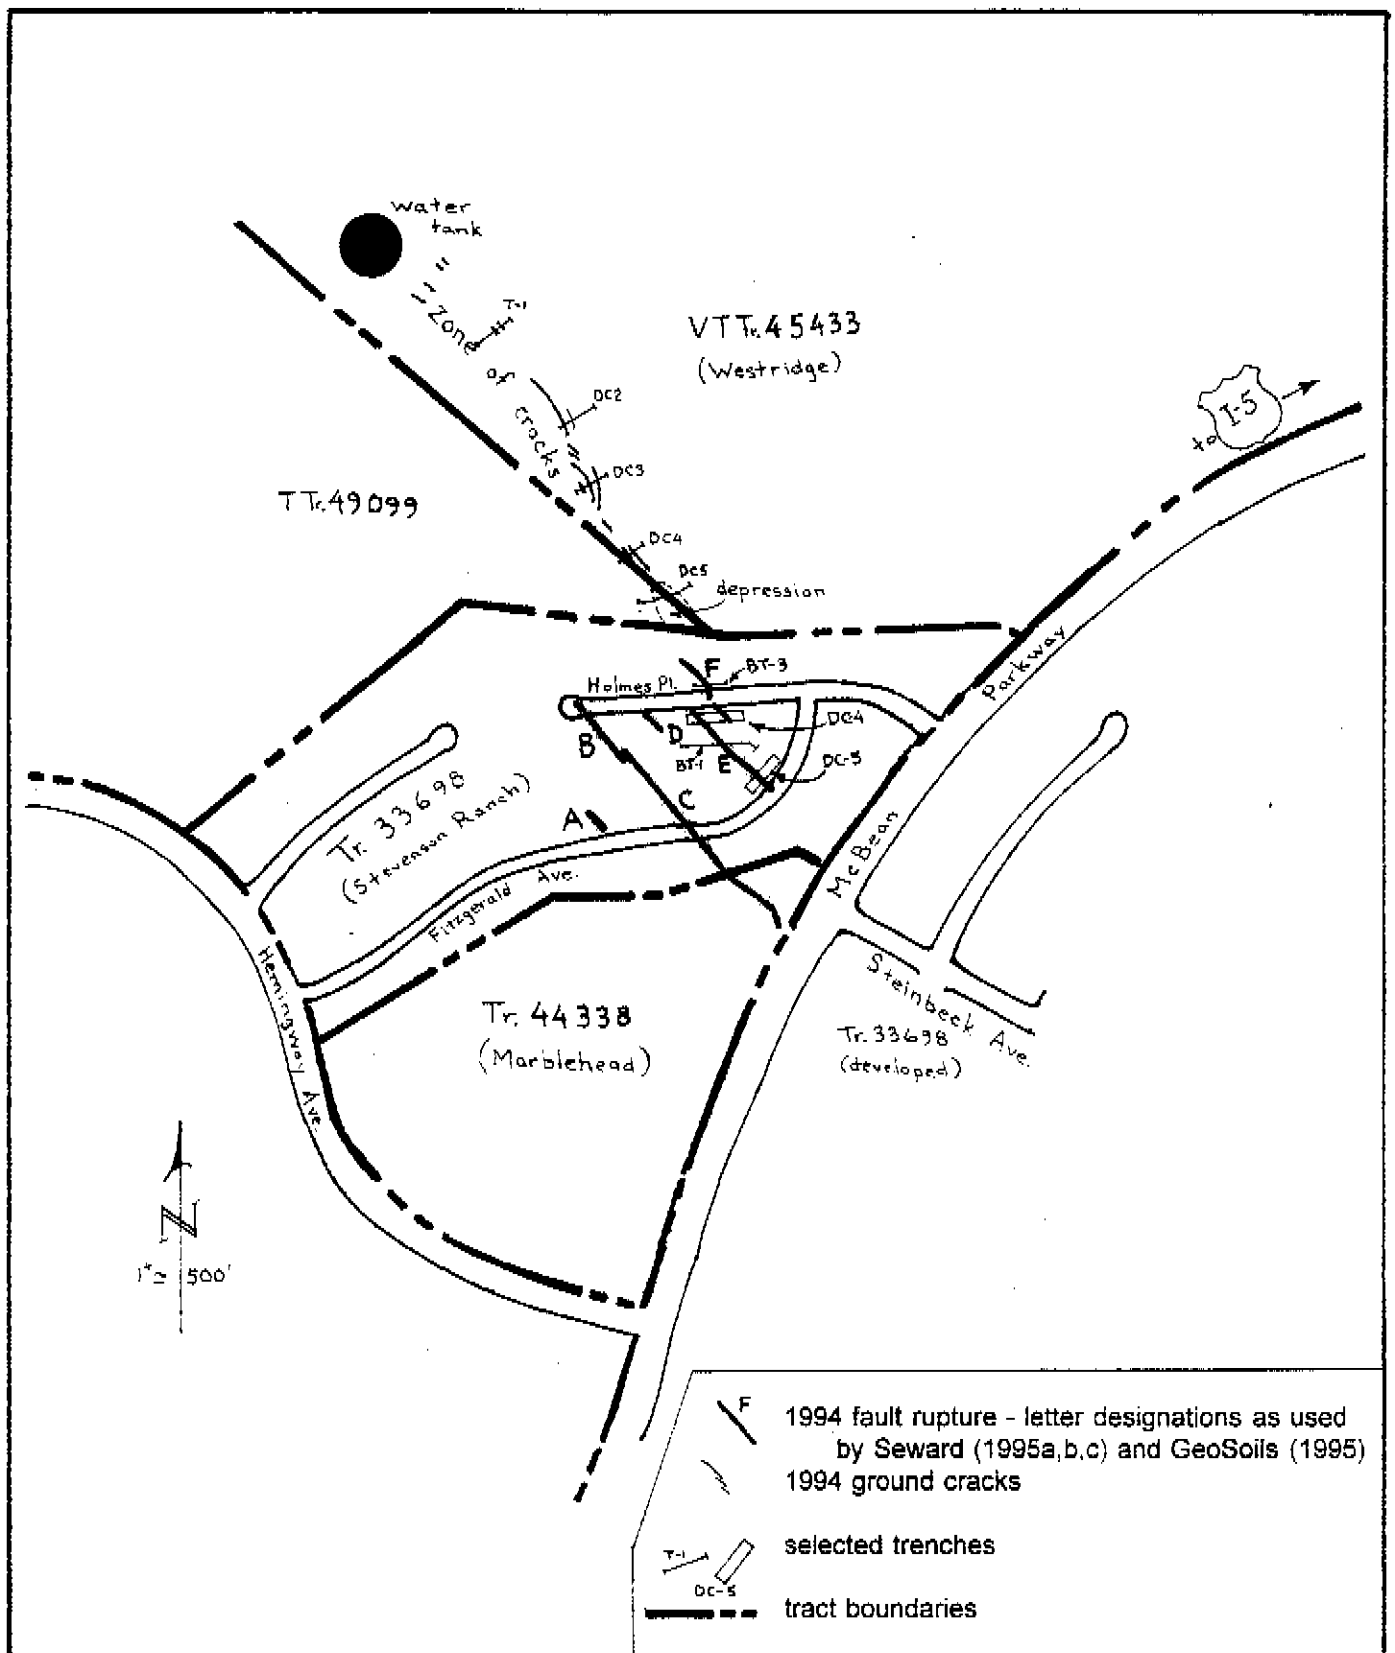
Surface displacements at the Stevenson Ranch and Marblehead developments have been identified along faults labeled A through F (see Figure 1). The displacements are interpreted by the consultants to be the result of seismically triggered elastic rebound as a response to prior removal of up to 83 feet of bedrock from a ridgeline (GeoSoils, 1995; Seward, 1995b,c). They claim that the greatest amount of uplift coincided with the area of deepest removal. A post-earthquake survey (of part of the graded area only) showed that the ground between faults B/C and E/F had been elevated (relative to the adjacent terrain)

Figure 1 (FER-242, supp.#1) - Index map to tracts, faults and selected trenches, including and adjacent to Stevenson Ranch (Tract 33698). Faults recommended for zoning (A-F) are highlighted.

up to one foot (GeoSoils, 1995). Most of this relative uplift occurred near faults B/C and E/F although some uplift was distributed between and beyond these two bounding fault zones. Faults A, D and E were considered minor (with 2cm or less vertical offset) and no building setbacks were recommended. Faults B and C had the largest surface displacements (up to 19cm) and are closely related by a short stepover. Fault D is near the contact between Saugus Formation and the overlying mid- to late-Quaternary sands and gravels of the Pacoima Formation. Fault E is adjacent to what Seward (1995c) calls a zone of tensional deformation at the eastern margin of the principal uplift. Fault F, also near the eastern uplift boundary, is recognized by GeoSoils (1995) but is not discussed by Seward (1995c).

The proposed zoning (CDMG, 1994) should be reduced to include only the well-defined faulting within the graded area (Figure 1). Within the graded areas of Stevenson Ranch and the Marblehead development clear co-seismic faulting has occurred along shears with ample evidence of prior displacements (Ruptures A-F). The area recommended for zoning also includes a narrow well-defined active fold or flexure with internal thrust faulting across bedding. Tectonically related surface warping is so narrowly constrained that it may damage a structure built across it. Structures should be set-back from the bending-moment thrust faults within the core of the concave-up fold as well as from bedding-plane faults within the Earthquake Fault Zone boundaries.

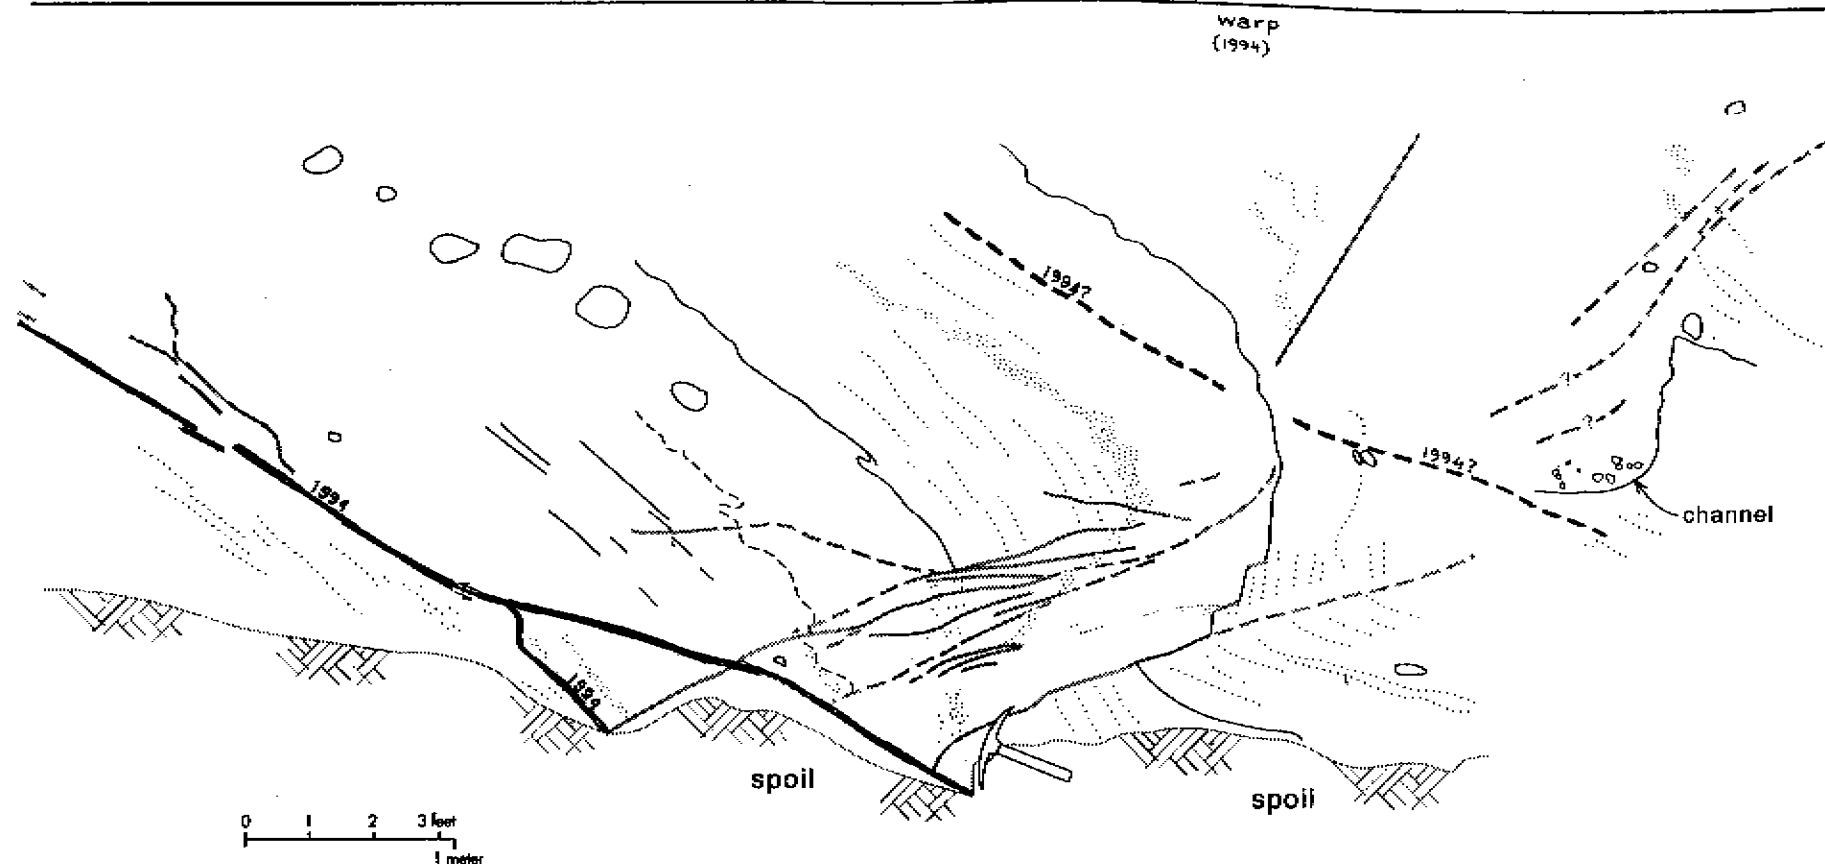
Seward (1995c) logged only the south wall of Trench DC-4 from Stevenson Ranch. GeoSoils (1995) logged both walls. I am including my own log of the north wall of DC-4 (Figure 2). I did not have the opportunity to see the deeper backhoe trench within this bulldozer trench.

Figure 2 (FER-242, supp.#1) - Sketch log of trench exposure (DC-4, Stevenson Ranch) south of Holmes Place. North wall of trench is shown. Trench depth is approximately 3.5m below street level. Bedrock is Pacoima (?) Formation. Multiple low-angle bending-moment thrust faults document a history of previous displacements that have folded the coarse sediments of the Pacoima (?) Formation. 1994 rupture surface (fault E), in the left portion of this sketch, offsets the southwest-dipping thrust surfaces. Rupture follows bedding-planes up to the left, from 2.5m depth to the surface. Queried 1994 rupture in upper central portion of sketch may be southern end of fault F. Surface warping in 1994 mirrored the older folding and was probably accompanied by incremental growth of this structure. (drawn from a 35mm slide)

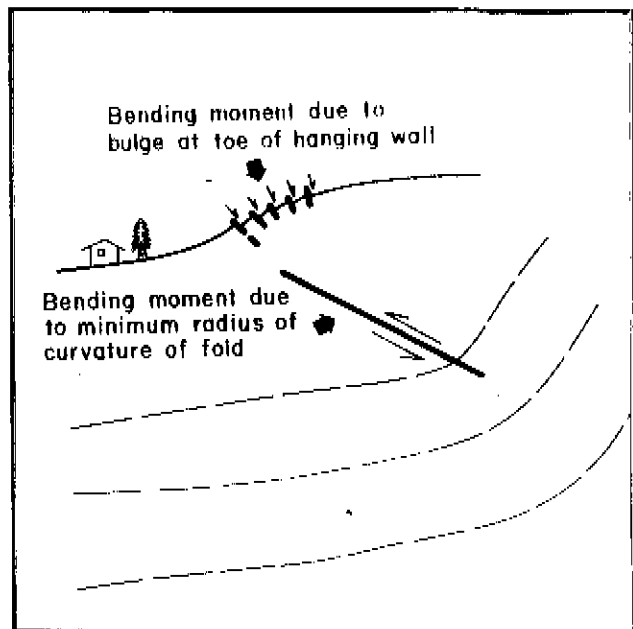
Figure 3 - Illustration of bending-moment thrust fault and related normal faults (modified from Yeats, 1982b, Figure 2).
